Weller WPA 2 repair. Gas would not ignite. Spark was ok. New fuel used. Read below for solution.

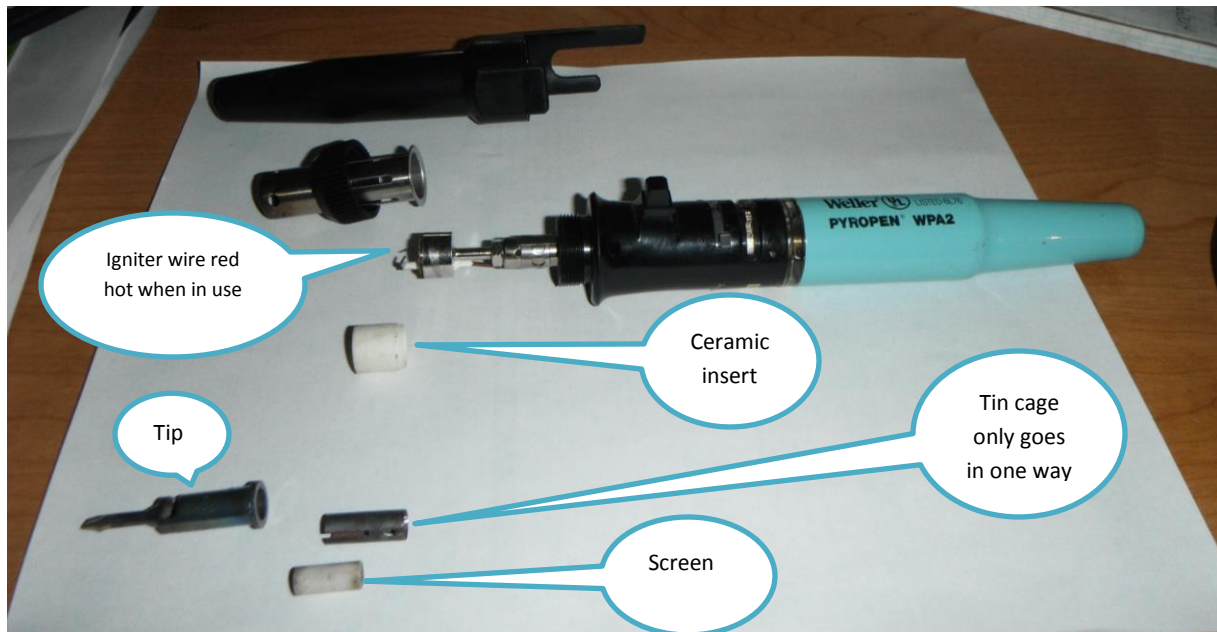
The tin cage and the screen should not be outside of the tip. They should remain pressed into the tip.

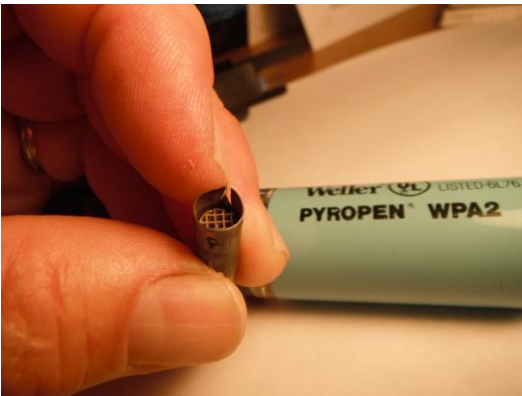
Here the screen has been inserted into the tin cage.

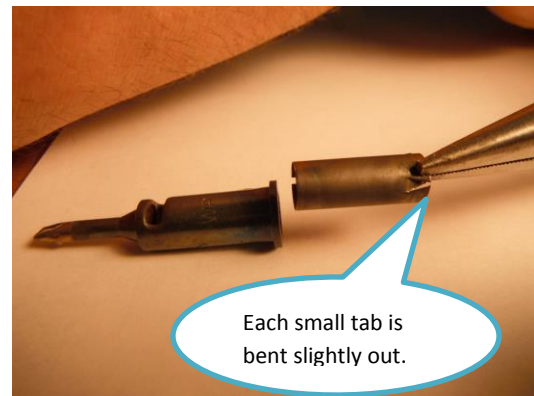
Each tab is bent slightly outwards. Look close.

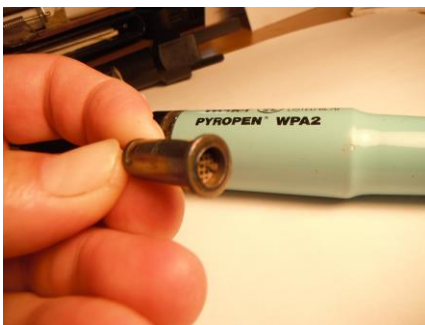
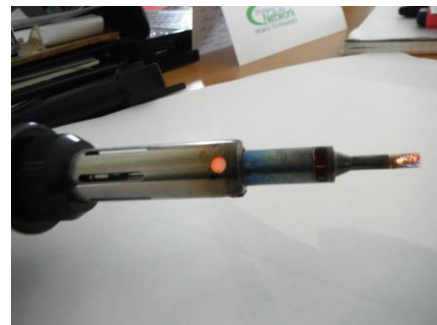
Tin cage and screen inserted in tip.

Success! Works every time now! Cheers.
